# UNDERWATER BRIDGE INSPECTION REPORT

STRUCTURE NO. 6613

RED LAKE RIVER

MINNESOTA DEPARTMENT OF TRANSPORTATION  
UNDERWATER BRIDGE INSPECTION

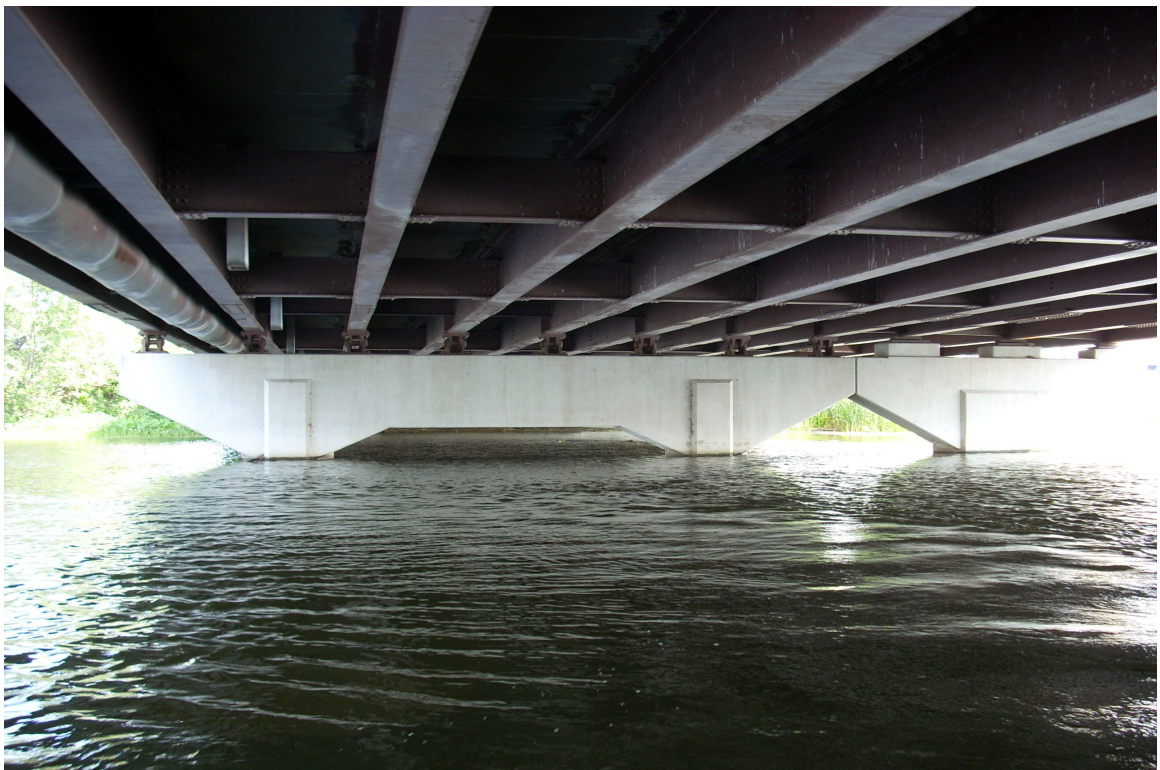
- (B) There was a light accumulation of 6-inch-diameter and smaller timber debris along Pier 2 on the channel bottom. A moderate accumulation of 1-foot-diameter and smaller timber debris was observed on the channel bottom to 5 feet above the channel bottom between Pier 1 Sections B and C and upstream of Pier 1 Section A.

- (D) Light scaling was observed on the shafts of Sections A and B at Piers 1 and 2 from the waterline to 2 foot below the waterline with a maximum penetration of 1/2 inch.

Photograph 2. View of Pier 1, Looking South.

- (A) Monitor accumulated timber debris around both piers during future inspections, and if found to be increasing, removal operations may be required at that time.
- (B) Reinspect the submerged substructure units at the normal maximum recommended (NBIS) interval of five (5) years.

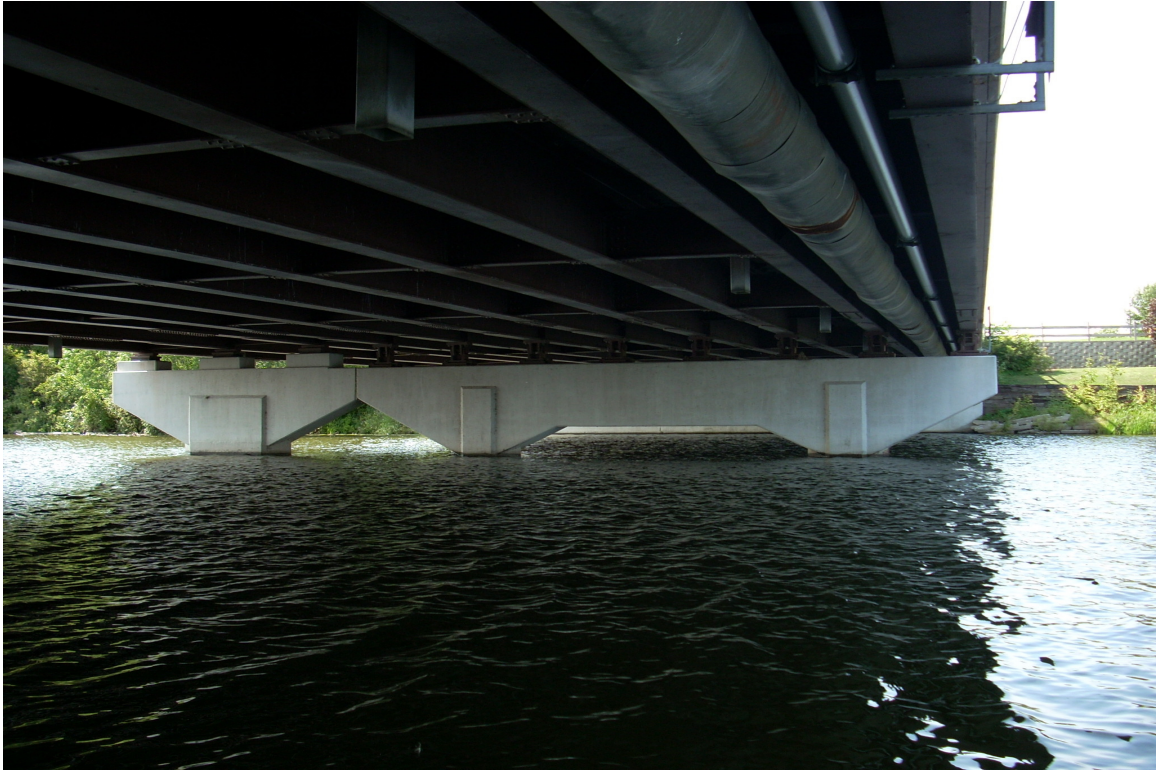
- (A) The footing at Section C of Pier 2 was exposed at 15.1 feet below the waterline around most of the pier section with a maximum vertical face exposure of 2 feet at the upstream end. In addition, the concrete strut connecting Sections A and B of Pier 2 exhibited 3 feet of vertical exposure. The top only of the footing at Section B of Pier 2 was also exposed 16.3 feet below the waterline on the southerly side.

Photograph 3. View of Pier 2, Looking South.

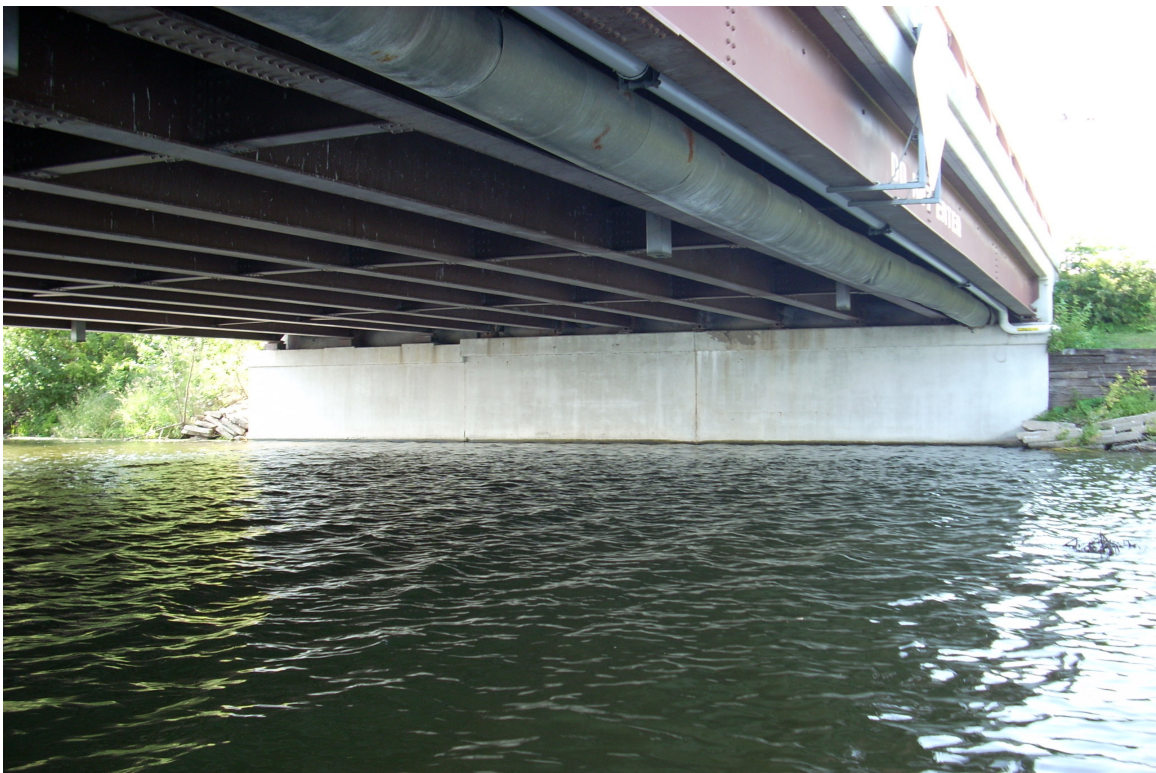
- (C) A vertical crack was observed in the construction joint from the top of cap to the channel bottom at the North Abutment, typically 1/16 inch wide and up to 1/8 inch wide at the bottom.

Photograph 4. View of North Abutment, Looking Northwest.

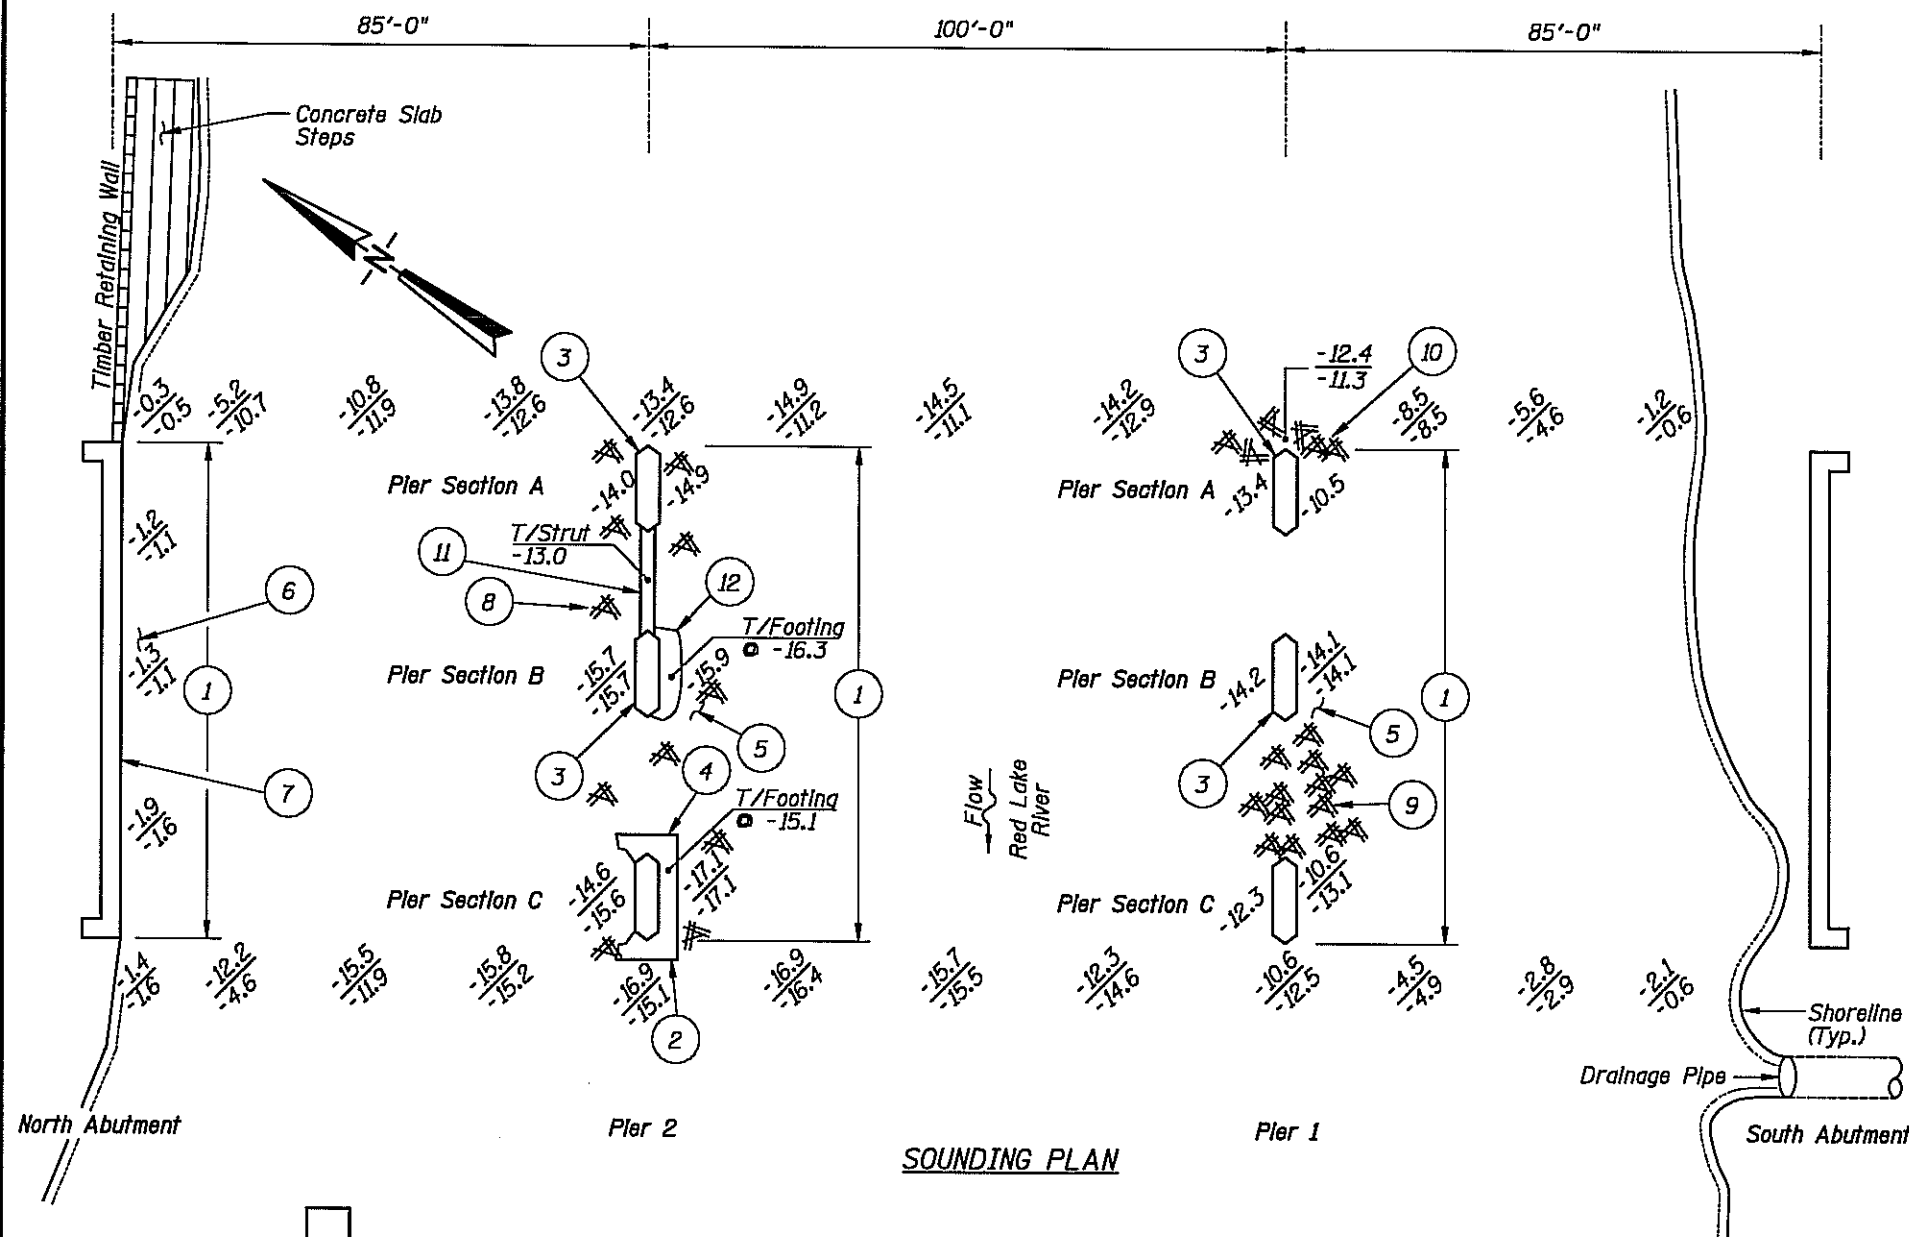
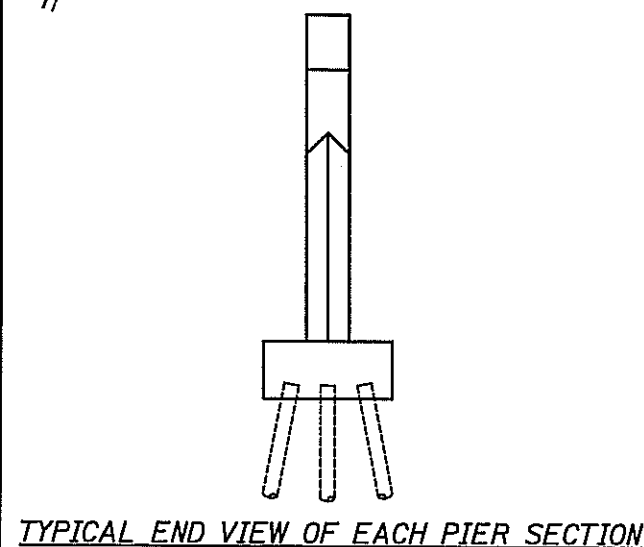
- 1 Overall, the concrete of the piers and abutment was smooth and sound with minor hairline cracking.
- 2 The top of the footing was exposed at 15.1 feet below the waterline along the south face, and upstream and downstream noses at Pier 2, Section C with a maximum vertical exposure of 2 feet.

- 3 Light scaling was observed on the shafts of Pier Sections A and B from the waterline to 2 feet below the waterline with a maximum penetration of 1/2 inch.

- 4 The timber footing formwork was observed extending up to 1 foot above top of footing around Section C of Pier 2.
- 5 The channel bottom at Piers 1 and 2 consisted of silty sand and random cobbles up to 12 inches in diameter with up to 1 foot probe rod penetrations.

- 6 The channel bottom consisted of silt at the North Abutment with probe rod penetrations of up to 1 foot.
- 7 A vertical crack was observed in the construction joint from top of cap to the channel bottom at the North Abutment, typically 1/16 inch wide and up to 1/8 inch wide at the bottom.

- 8 A light accumulation of 6-inch-diameter and smaller timber debris was observed along Pier 2 from the channel bottom to 2 feet above the channel bottom and up to 3 feet off the faces and noses.

- 9 A moderate accumulation of 1-foot-diameter and smaller timber debris up to 10 feet wide was observed from the channel bottom to 5 feet above the channel bottom between Pier Sections B and C.

- 10 A moderate accumulation of 1-foot-diameter and smaller timber debris was observed from the channel bottom to 5 feet above the channel bottom at the upstream nose of Pier Section A of Pier 1 the debris was 10 feet long (N/S) by 4 feet wide (E/W).

- 11 The concrete strut connecting Sections A and B of Pier 2 exhibited 3 feet of maximum vertical exposure at Pier Section B.
- 12 The top of footing was exposed at 16.3 feet below the waterline along the south side Section B of Pier 2 with no vertical exposure.
